**Forest  
Practices  
Board**

## **Forest Practices near Wilson Creek on the Sunshine Coast**

*Complaint Investigation #18032*

**FPB/IRC/218**

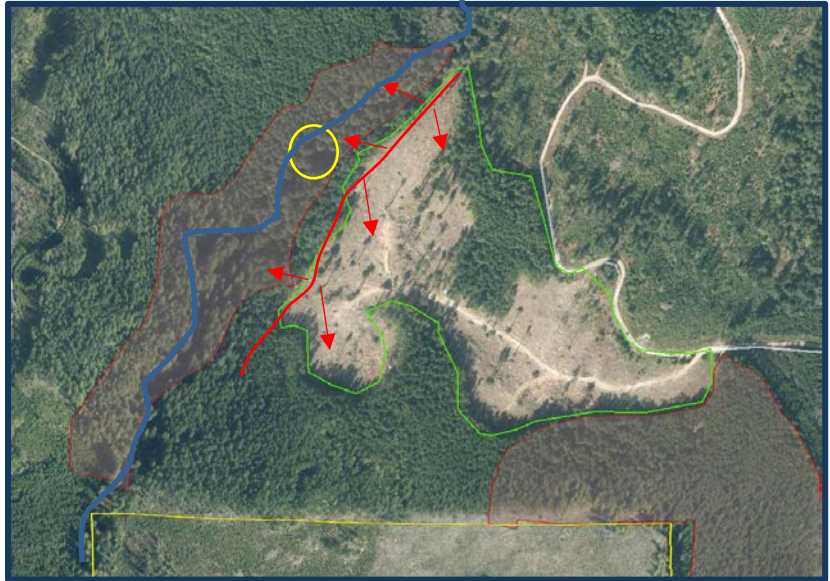
**Figure 2.** Cutblock EW002. The blue line is the approximate location of the creek, the red line shows the approximate drainage split and the red arrows indicate the drainage pattern on the cutblock. The yellow circle is the approximate location of the slump, the yellow line is the SCCF boundary and the shaded areas are old growth management areas. Most of the water coming off EW002 does not reach the slump.

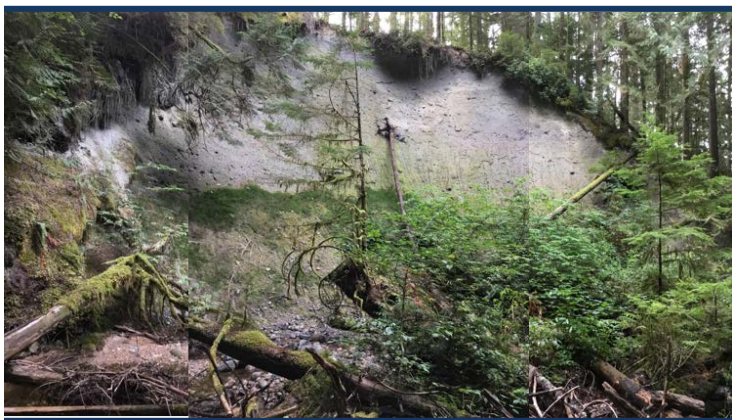
**Picture 1.** The retrogressive slump adjacent to Wilson Creek. Note the revegetation of the toe of the slump.

The forest activities of SCCF did not cause the slump that the complainant identified: the slump was a natural event that occurred before any primary forest activity took place. The design and development of cutblock EW002 did not affect or increase the sedimentation that is naturally occurring from the slump. Further, Board investigators observed that the toe of the slump is beginning to revegetate, which will reduce the amount of sediment from the slump introduced into Wilson Creek in the future.

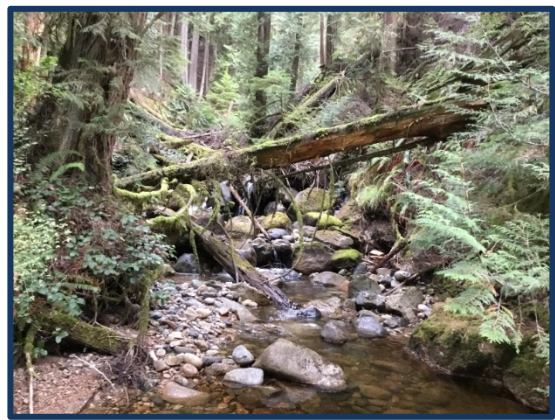
Wilson Creek is fish bearing and has domestic water intakes located approximately two kilometres downstream of cutblock EW002. The northwestern-most boundary of the cutblock parallels Wilson Creek for approximately 500 metres. The creek is about 25 to 60 metres downslope from the cutblock and only a small portion of the cutblock drains into it (Figure 2). The stream bank along this section of Wilson Creek is very steep, ranging from 45 percent to over 100 percent gradient (refer to Photos 1 and 2).

**Picture 2.** Wilson Creek, looking upstream from the slump.

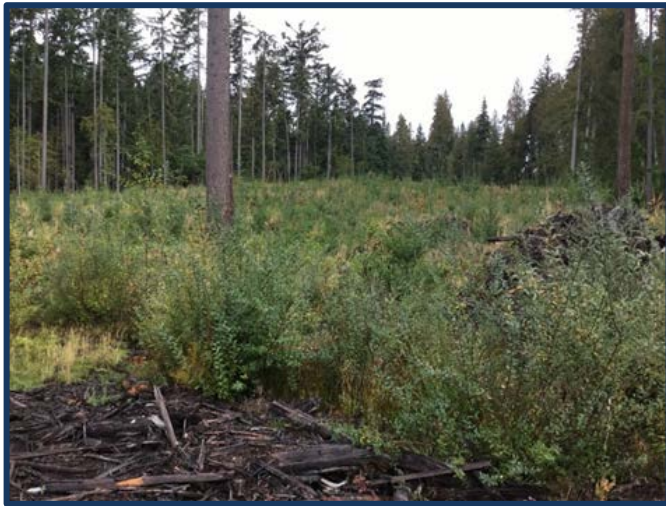
**Figure 5.** Cutblock EW002. Note the gentle terrain and vigorous regeneration and thick shrub component. Wilson Creek is to the left of the cutblock.
