TERRAIN STABILITY HAZARD ASSESSMENT

Blocks AN03, AN3A, and AN15

Grey Creek

Project Number: 21-187
August 9, 2022

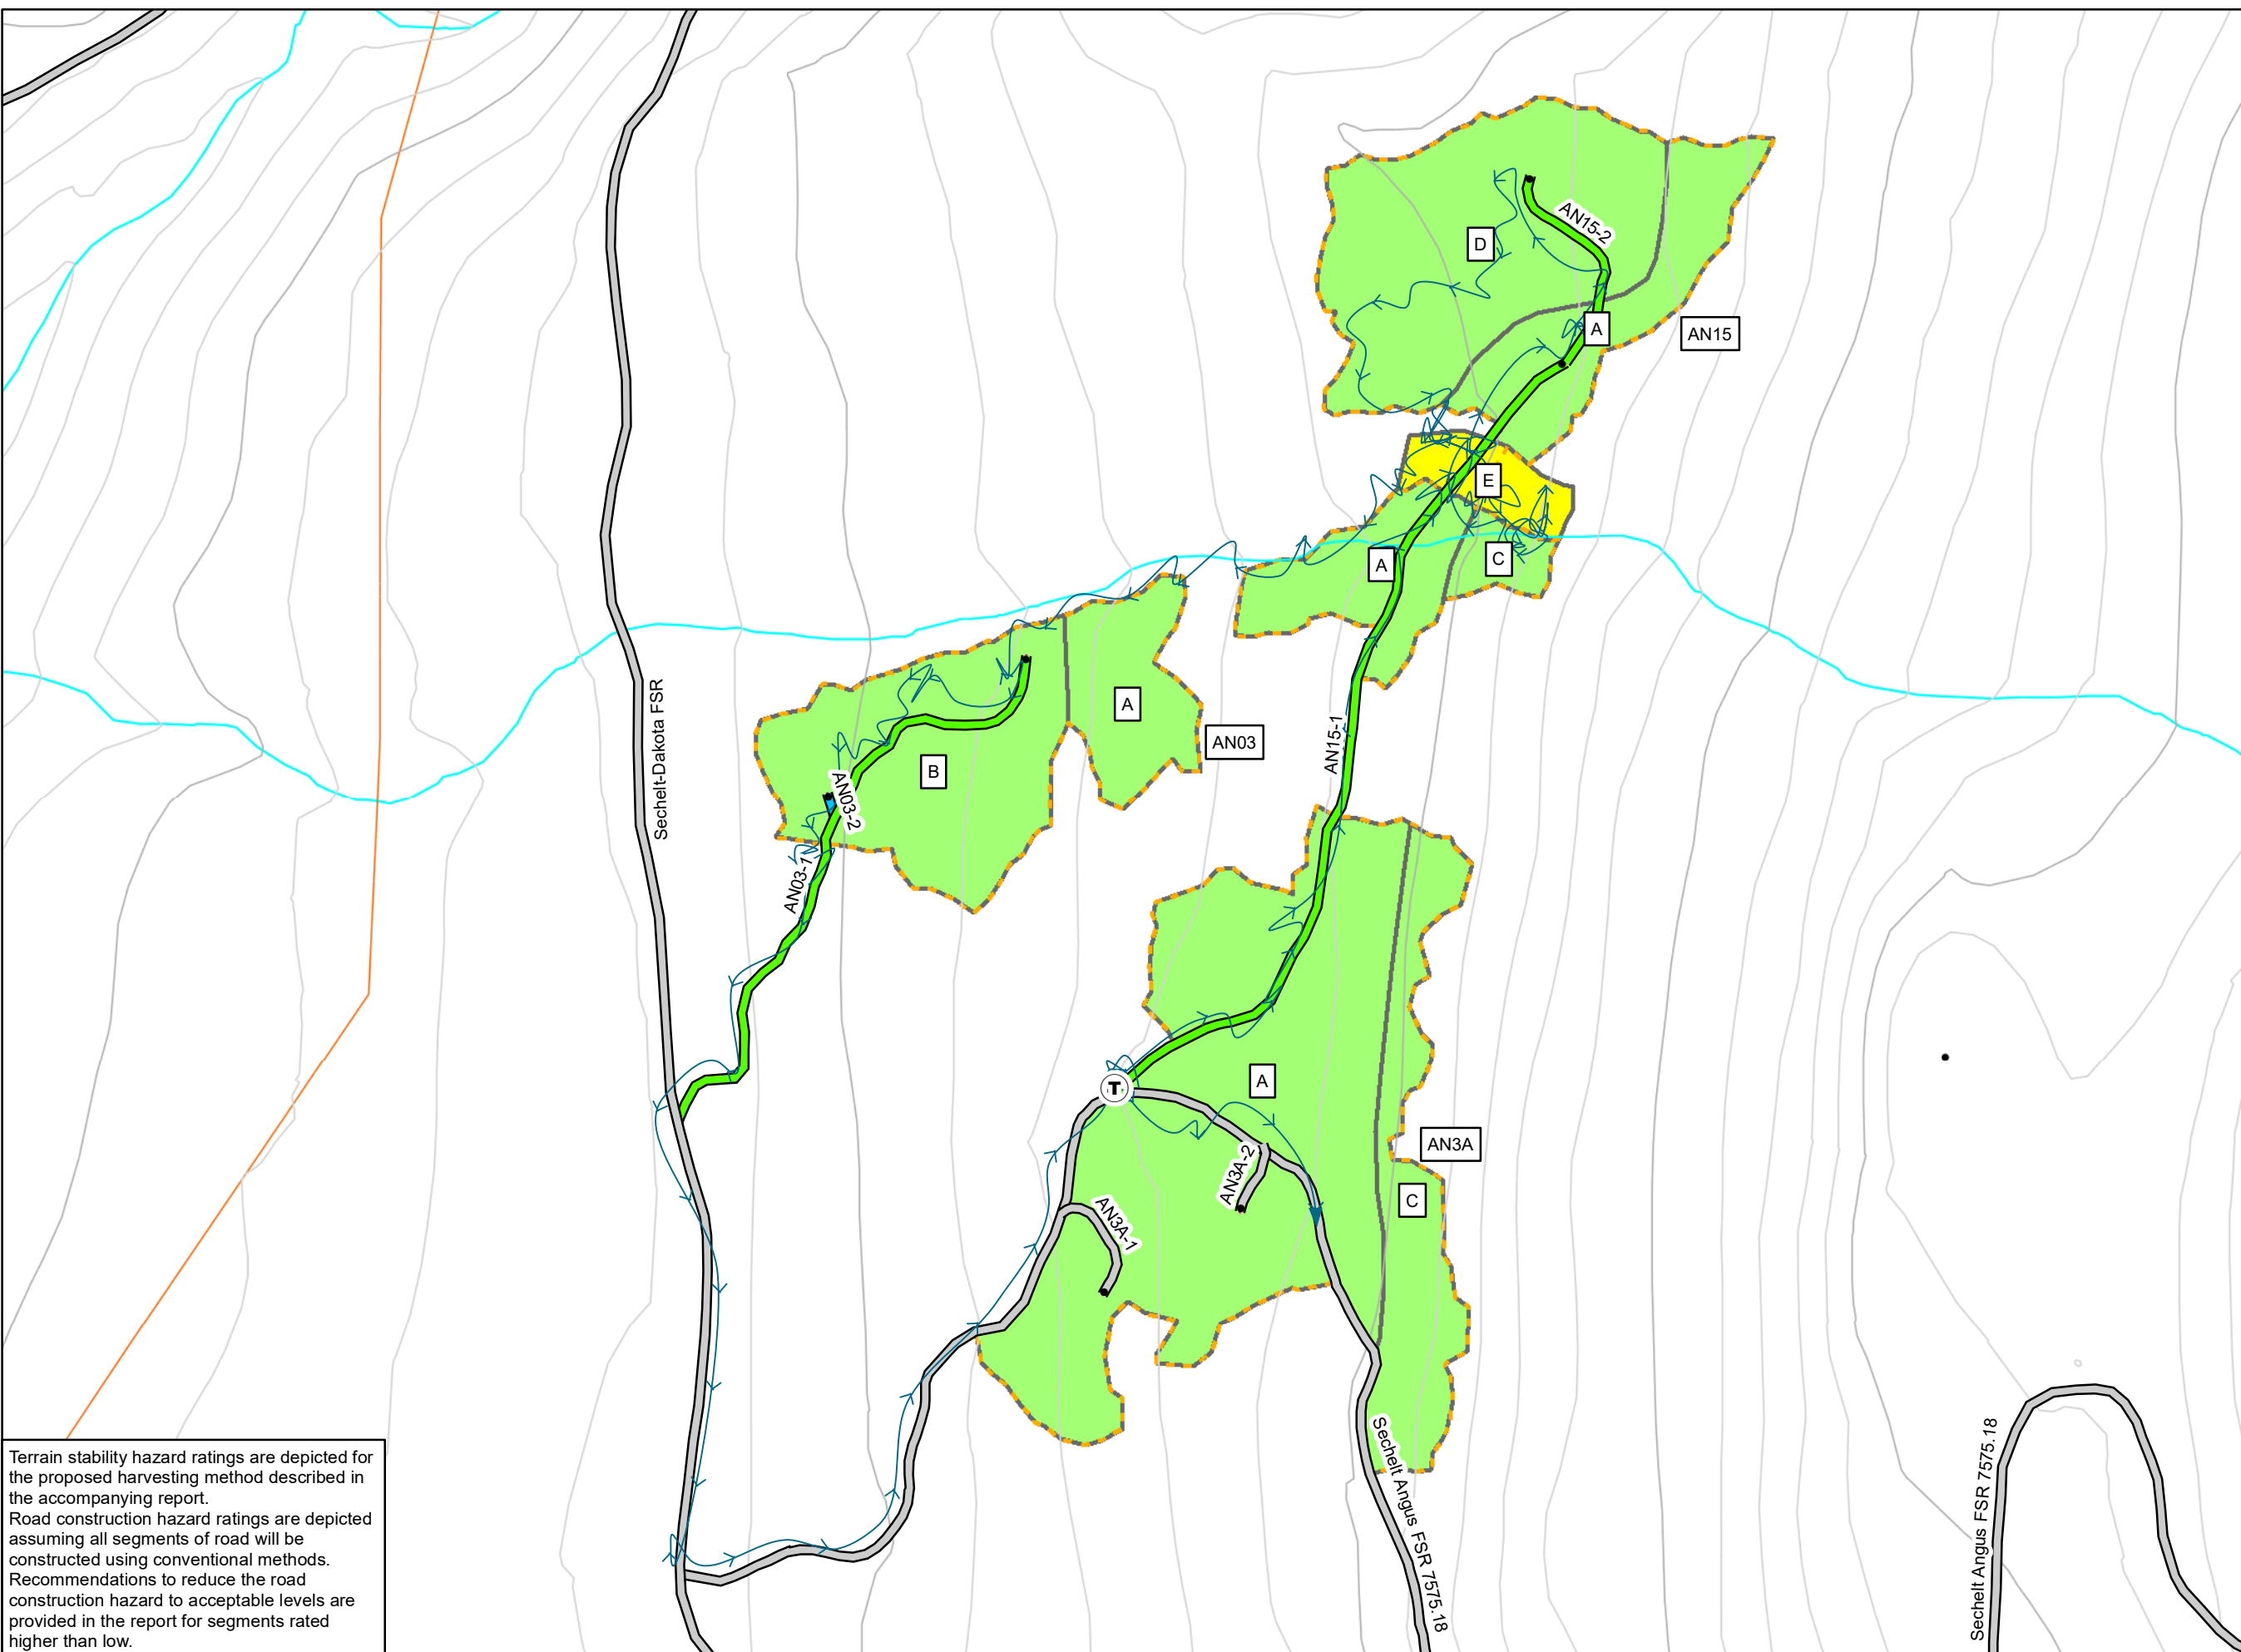
Figure 1:
Road and Terrain
Hazard
Blocks AN03, AN3A, & AN15
Angus Creek

The terrain in the blocks was divided into polygons based on homogenous terrain stability hazard, surficial materials, topography, drainage, and slope gradients (Figure 1). The block boundaries were not used as part of my terrain mapping because the blocks are close to each other; therefore, terrain polygons may sometimes occur in more than one block.

The terrain in Polygon E has moderate terrain stability hazard. Harvesting the trees up to the skid trail above the stream could result in potential stream avulsions that would flow down the old skid trail. An avulsion would reach Br. Road AN15-1 and cause a road washout. The boundary segment between FC 17 and FC 17-3 was moved 20 m to the south, away from Stream A to reduce the potential for channel avulsions after harvest.
