TERRAIN STABILITY HAZARD ASSESSMENT

Block HM50

Halfmoon Bay, Sunshine Coast

April 6, 2020

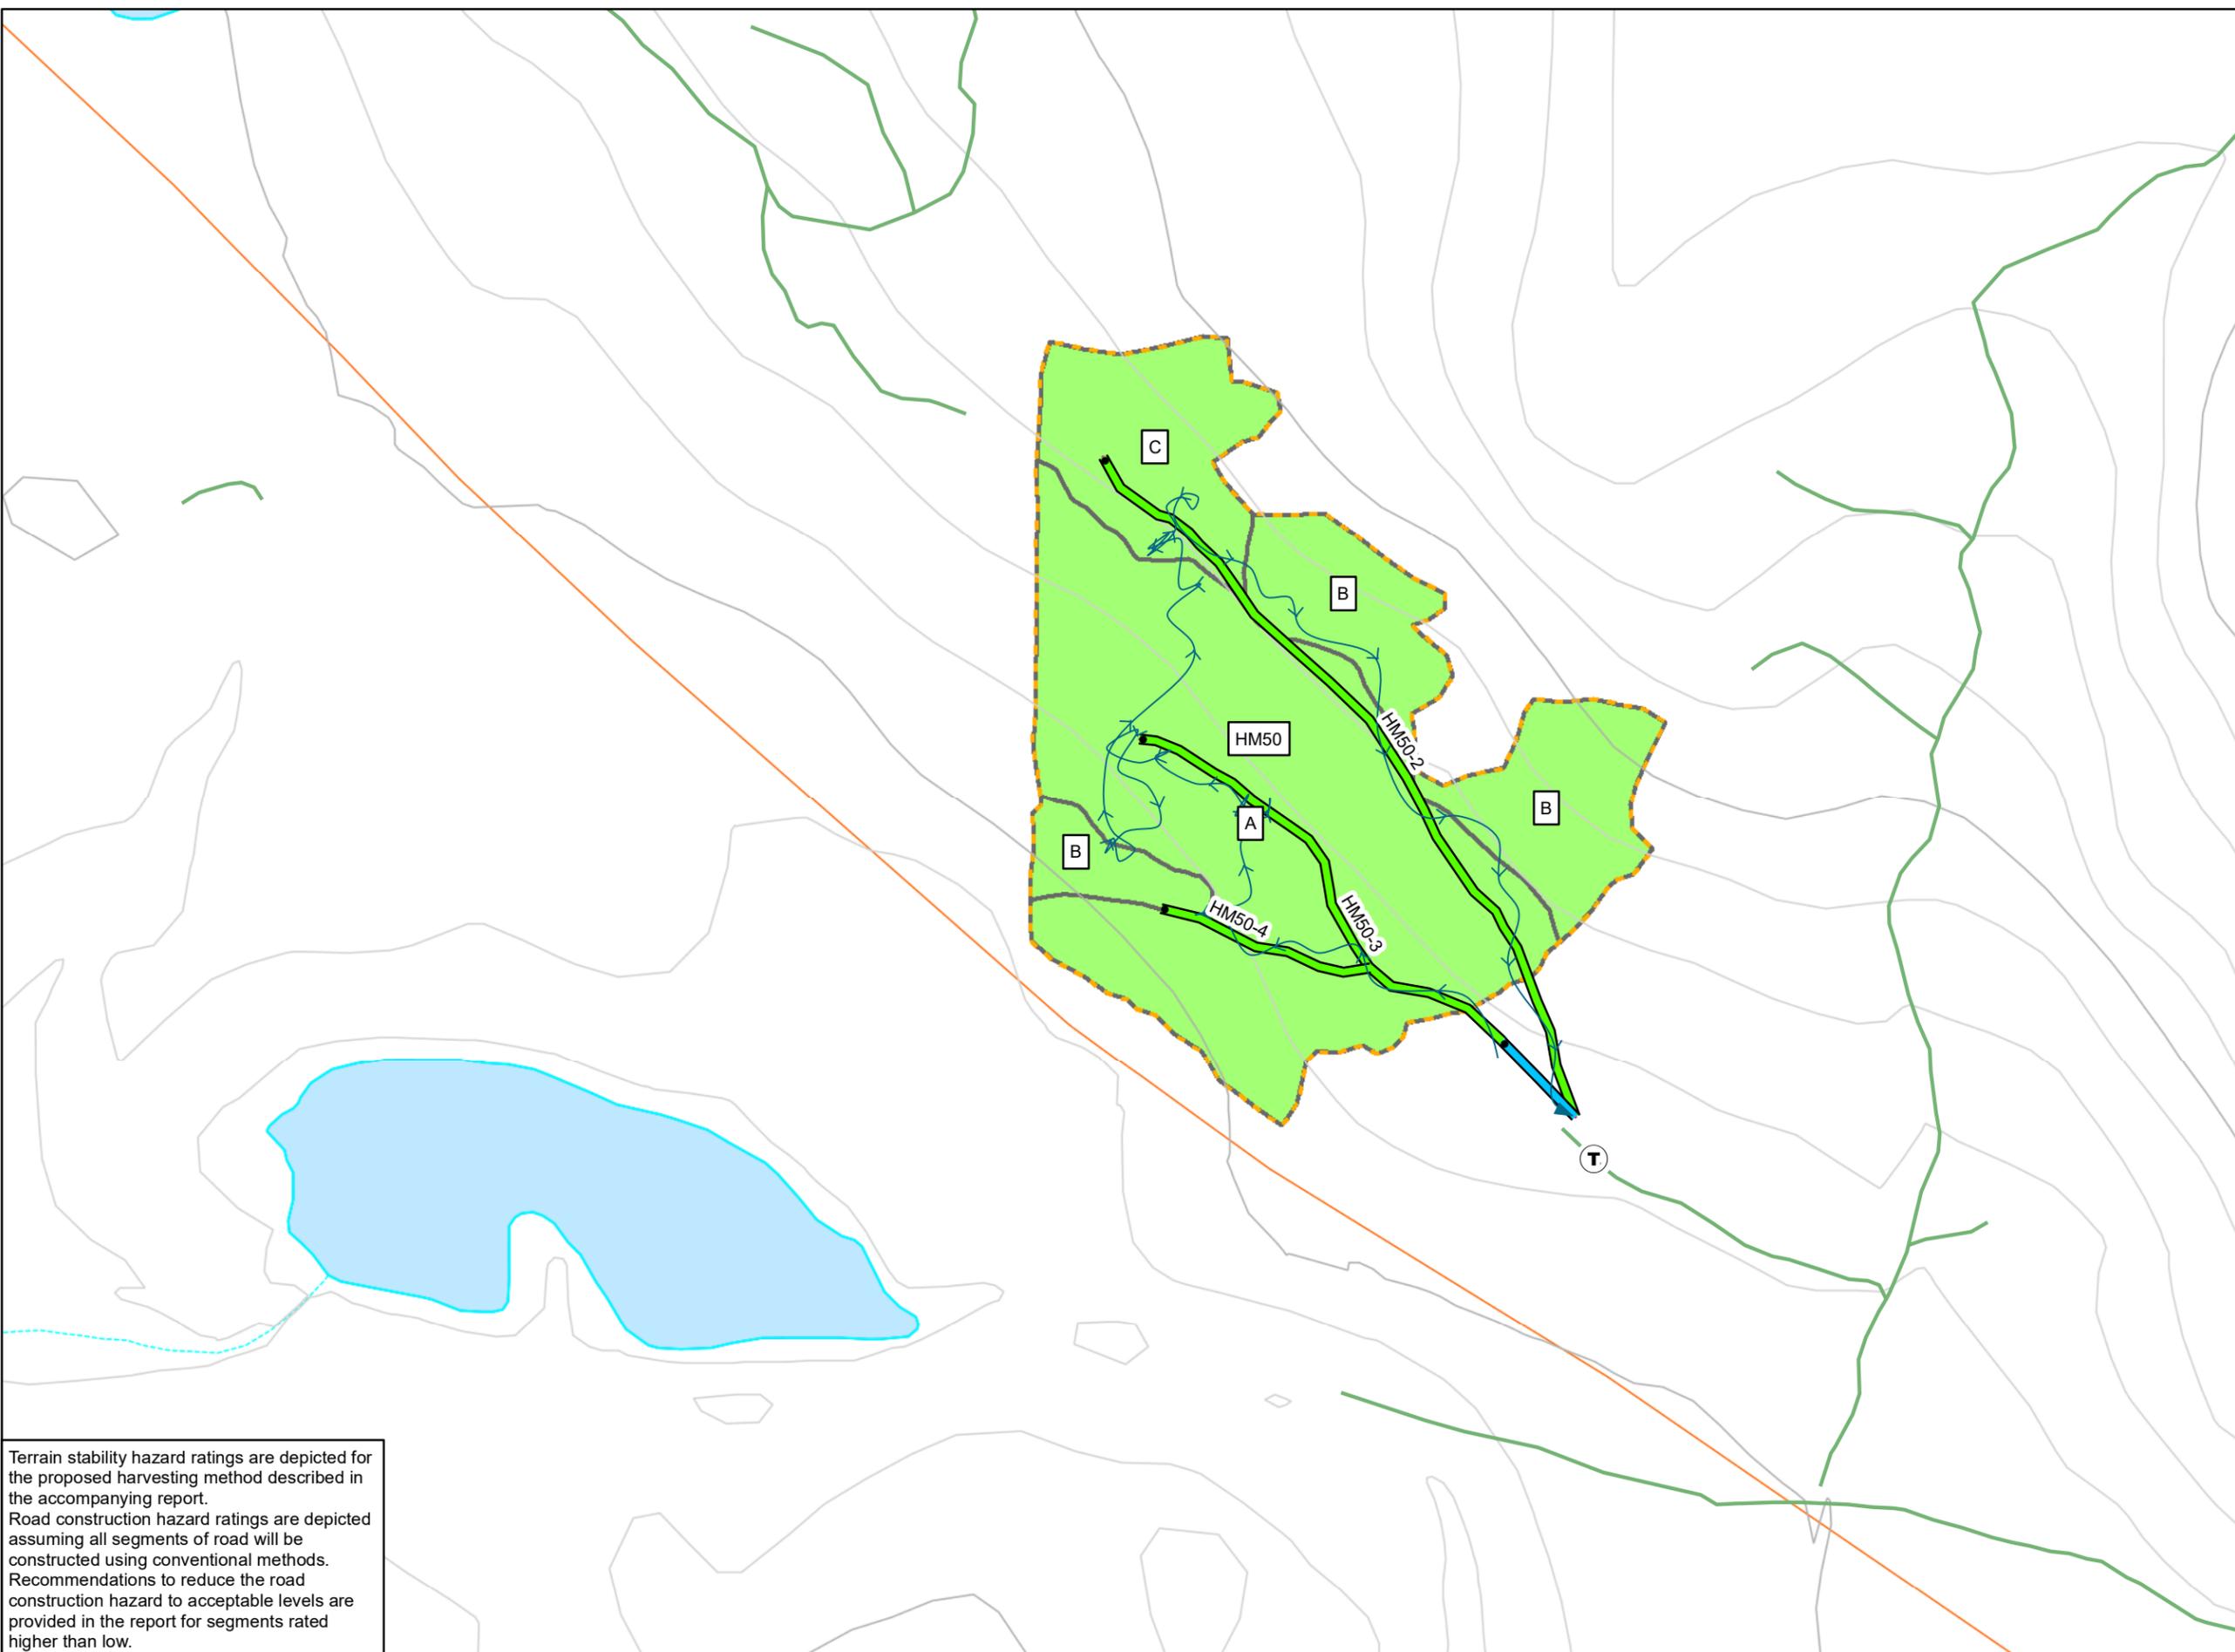
Figure 1:
Road and Terrain
Hazard
Block HM50
Half Moon Bay

Polygon A will have low terrain stability hazard for ground-based yarding methods. Small landslides, less than 20 m³, could deposit within a few meters of the initiation site onto the surrounding gently sloped terrain.

Polygon B will have low terrain stability hazard for restricted ground-based yarding methods. Timber across greater than 40% slope gradients can be felled into lead. Landslides of less than 30 m³ could deposit up to 25 m downslope onto gentle slope gradients within the block.

Polygon C presents low terrain stability hazard for ground-based yarding methods. Landslides could deposit within 10 m of the initiation site onto gently sloped terrain within the block.

Br. Road HM50-2 will be new construction. It branches off Spur 210 to crosses planar to hummocky topography with slope gradients between 5% and 35%. The surficial material consists of a moderately well- to well-drained rubbly to sandy till veneer to mantle. Conventional construction will result in low terrain stability hazard. A road failure could deposit within a few meters of the road.

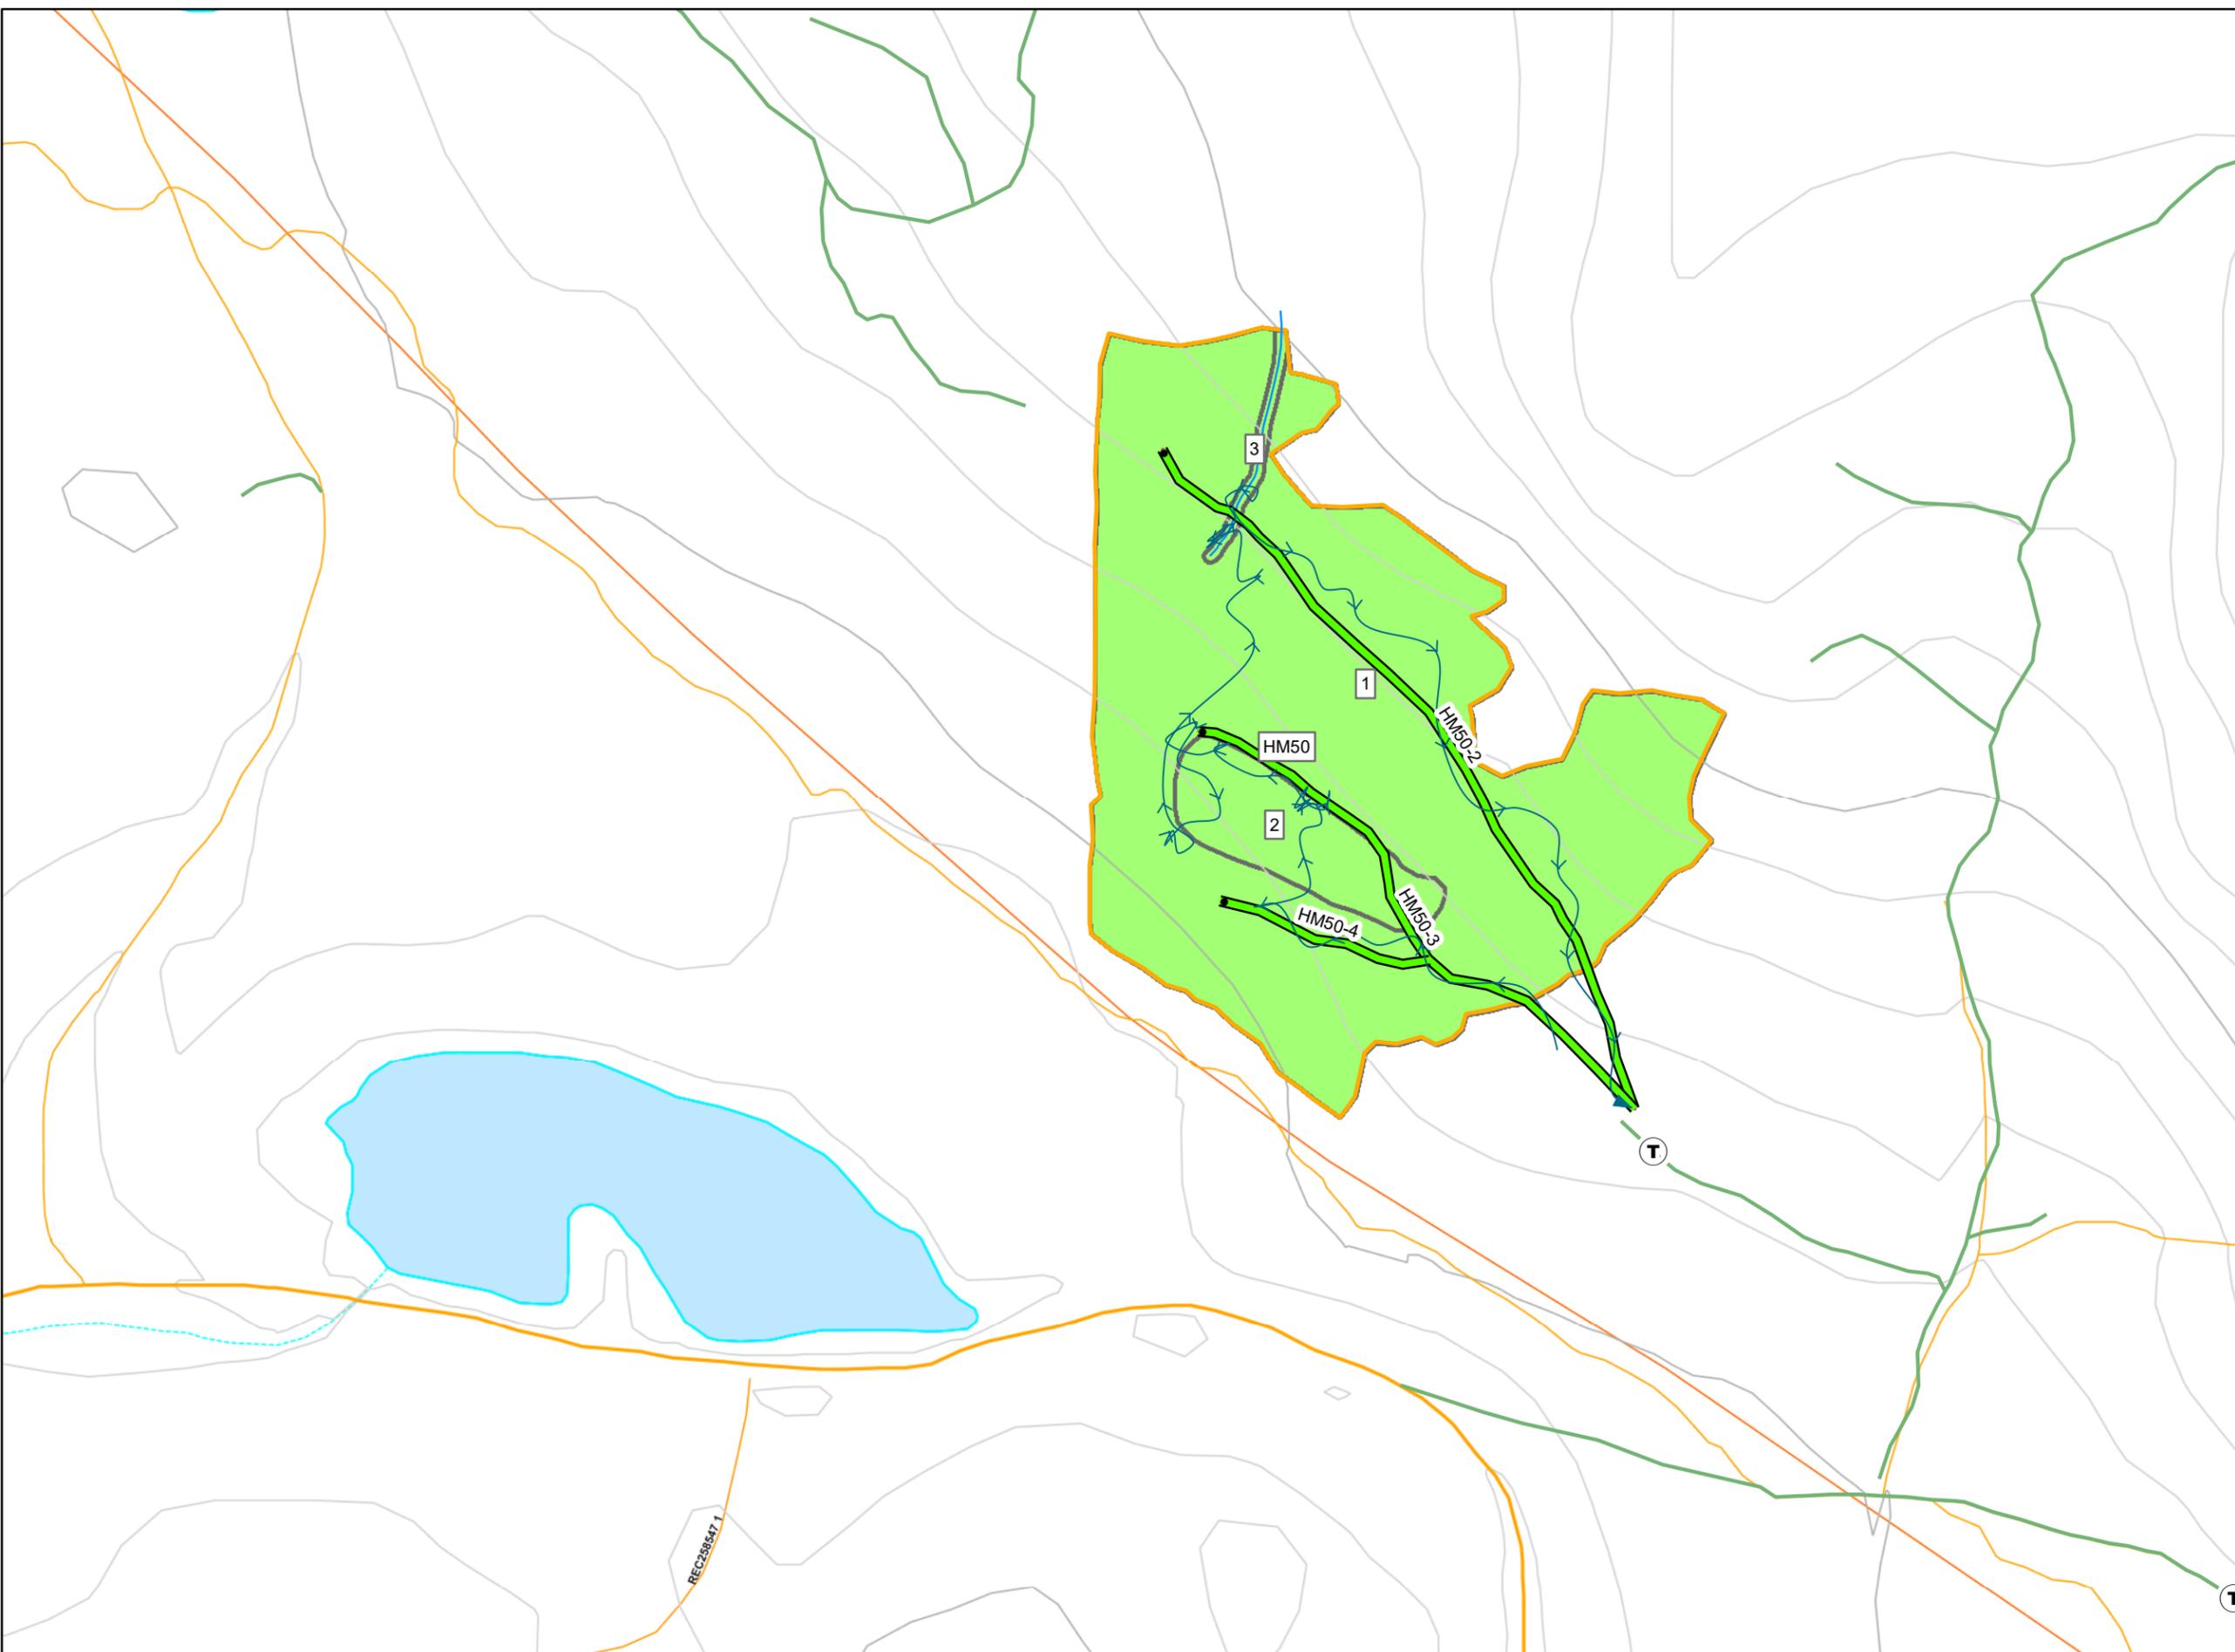
**Figure 2:
Sedimentation
Hazard
Block HM50
Half Moon Bay**

Polygon 1 includes the majority of the terrain within Block HM50. The slope gradients are between 0% and 50%, with planar to hummocky morphology. Soils have a sandy texture with up to 30% rubbly coarse fragments and are moderately well- to well-drained. There are no streams in the polygon. The polygon has high soil erosion potential and low sediment delivery potential, which results in low sedimentation hazard.

Polygon 2 comprises a low-lying wet area within the middle section of the block where discontinuous pools of standing water were observed. Slope gradients are less than 15% and topography is planar with sandy loam soils with imperfect drainage. Bedrock forms a water restricting layer at 50 cm or more depth. This area appears to concentrate surface runoff and may act as a sediment sink, however it is not connected to any sensitive receptors. Therefore, it has high sediment erosion potential and low sediment delivery potential, so the overall sedimentation hazard is Low.

The road segments in Block HM50 have low sediment delivery potential because ditch networks are separated from streams. At Sta. 0+571, Br. Road HM50-2 crosses the S4 stream in Sedimentation Polygon 3. The stream did not appear to have constant water flow, as it was dry at the time of the assessment, it dewatered approximately 20 m below the road, and it is not connected to any sensitive receptors. Therefore, the road crossing has an overall low sedimentation hazard. To maintain this low hazard, ensure any water flowing within the road ditch near the stream crossing is not directed towards to the stream.

- Ground based harvesting should occur under dry conditions, particularly on slopes steeper than 30%. When harvesting within the low-lying wet area (Polygon 2), where concentration of surface runoff has resulted in discontinuous pools of standing water, ensure all equipment working in this area is tracked and implement 5 m wide machine free zones (MFZ) around any pooling water that may be present.
