HYDROLOGIC ASSESSMENT

Kenyon Creek Watershed Sunshine Coast

Project Number: 22-109

May 12, 2022

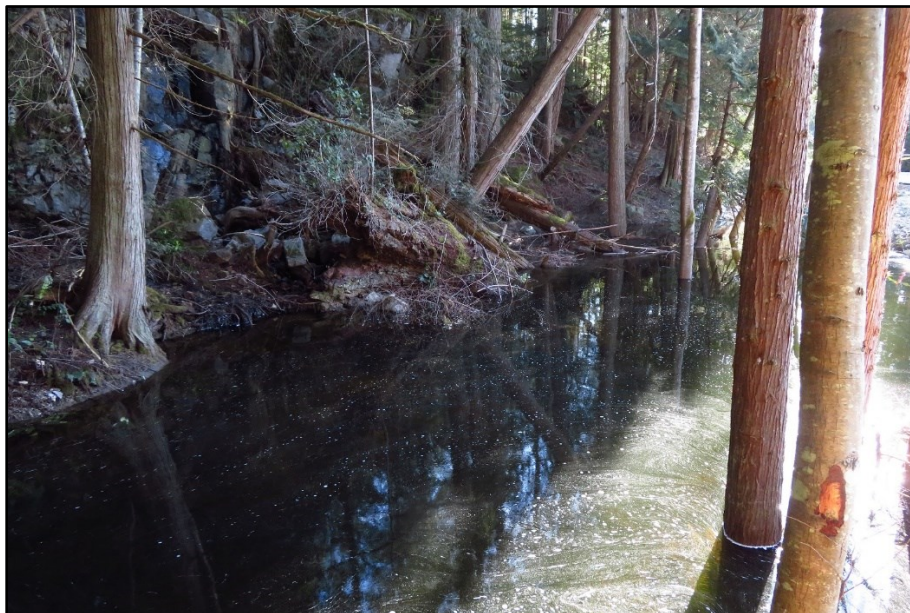
Redrooffs Road was washed out where it crosses Kenyon Creek during the November 2021 atmospheric rivers, about 400 m upstream of its mouth in Sargeant Bay. It had only been recently repaired at the time of our field visit in February. The repairs consisted of placing coarse rock fill and several culverts and then paving the road running surface. The new fill placed across the creek had effectively created a dam which formed a pond upstream of the road. The water level in the pond was up to about 3 m deep in places. Trees near the pond were dying because they had been flooded and their roots were under up to 1 m depth of water (Photo 1).

Photo 1: Ponding above Redrooffs Road

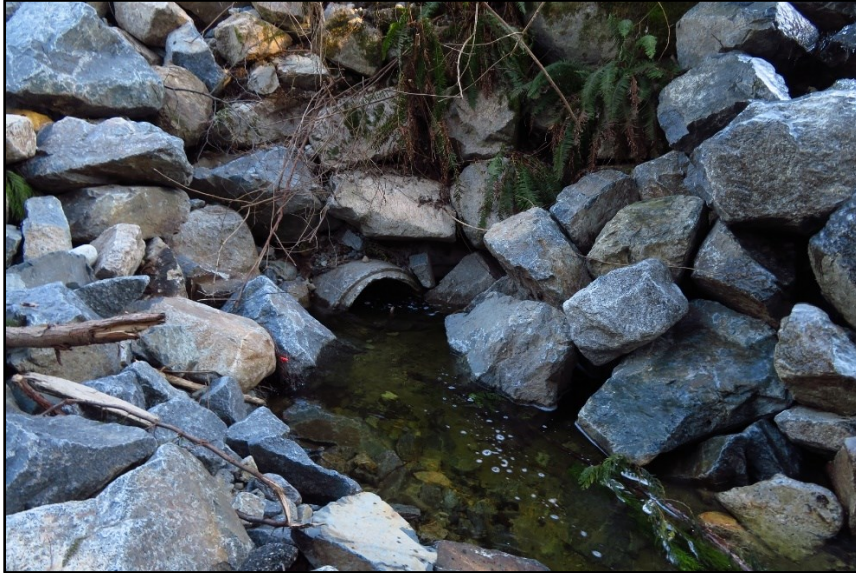
Several culverts had been placed in the repaired road fill. In total, we counted an 800 mm concrete pipe culvert at the base of the fill (which appeared to be the original culvert in place from before the washout, Photo 2), a new 1000 mm corrugated metal pipe culvert, and four separate new 600 mm black plastic pipe culverts. These latter five culverts are just below the asphalt of the road and discharge onto the top of the coarse rock fill (Photo 3).

Photo 2: Concrete culvert at base of Redrooffs Road fill

The Redrooffs Road crossing may have had undersized drainage structures. I do not know what was in place before the washout but it may have been a drainage structure as small as the 1000 mm diameter concrete culvert which is now in place at the base of the replacement fill. It may even have been the same concrete culvert.

The replacement drainage structures at Redrooffs Road, and the existing drainage structures at Belair Road and Leaning Tree Road, all appear to be undersized for the calculated 1% AEP flood magnitude for Kenyon Creek. SCCF should provide this information to BC MOTI, who are responsible for the maintenance of these structures, so that they may incorporate it into plans to upgrade such drainage structures and therefore prevent future washouts.

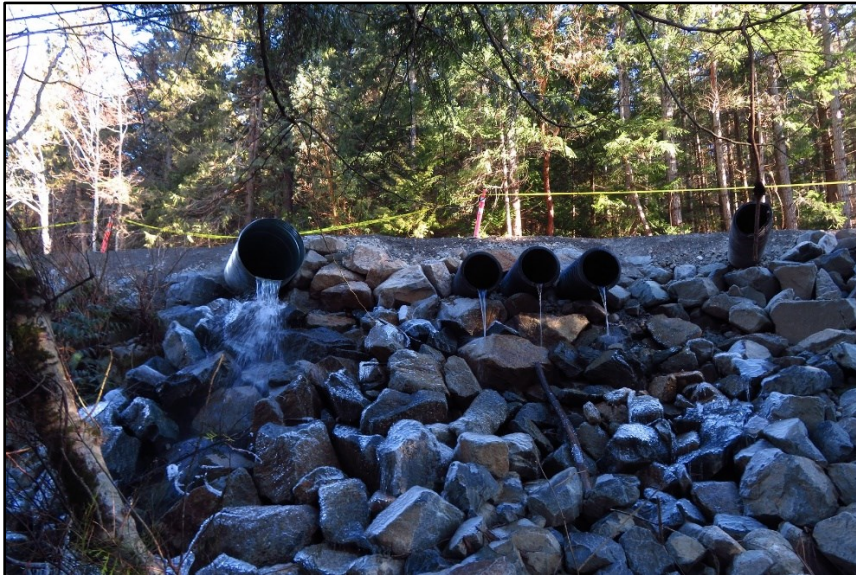
Photo 3: New metal and plastic pipe culverts

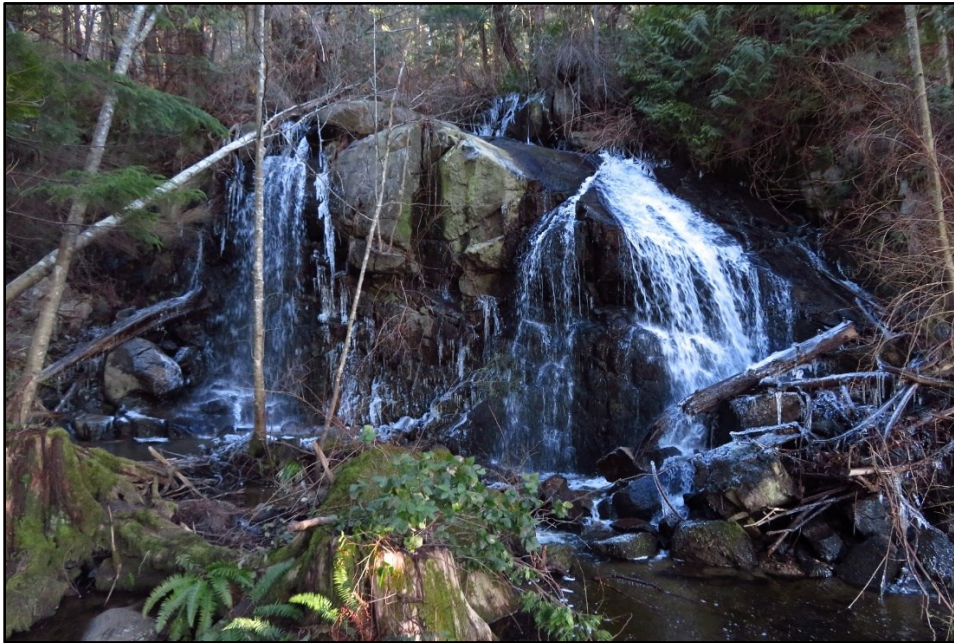
A 6 m high waterfall flows directly into the head of the pond by Redrooffs Road (Photo 4). Above this waterfall, Kenyon Creek flows over benchy bedrock steps. Sediment has deposited on the benches between the steps. On the steeper steps, Kenyon Creek has a bedrock channel and flows over bare rock and boulders. The November 2021 flood could not erode down through this bedrock so the high flows scoured moss and soil from each side of the channel on the steep steps, exposing additional bedrock. Wood pieces and cobble sized sediment were also moved by the flood and deposited on the steps, though the deposited sediment is mostly sand and gravel (Photo 5).

Photo 4: Waterfall upstream of Redrooffs pond

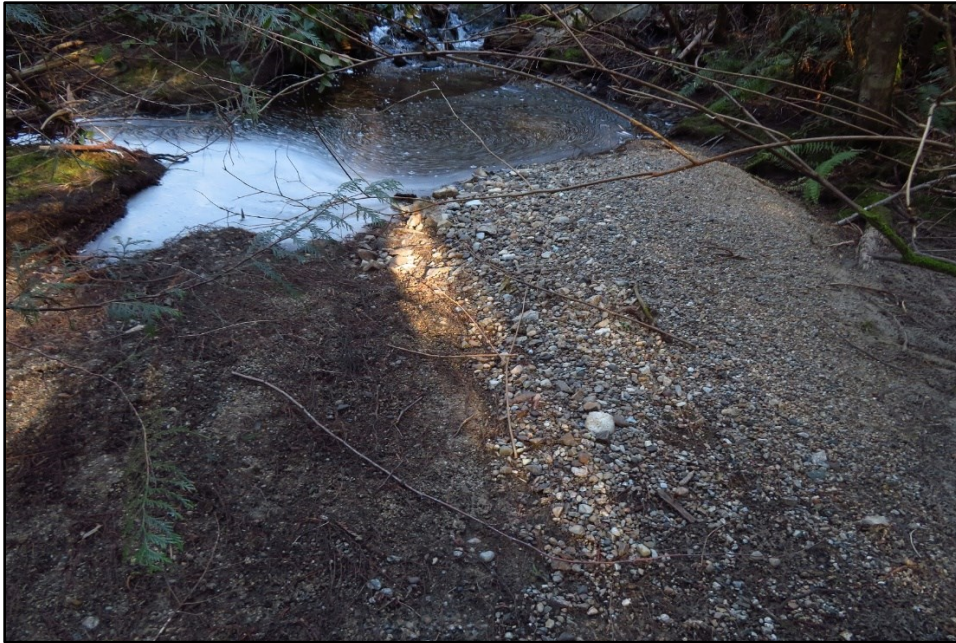
Photo 5: Sediment and wood deposited above waterfall

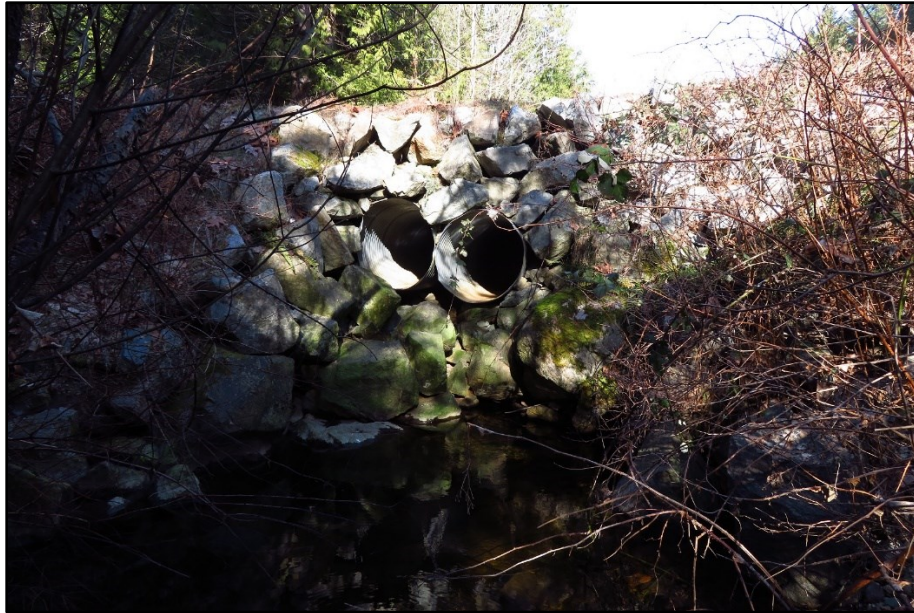
Both Leaning Tree Road and Belair Road cross Kenyon Creek on coarse rock fill placed over culverts. At Leaning Tree Road, there are two, side by side, 1000 mm diameter corrugated metal pipe culverts. Water was flowing through the coarse rock fill and not through the culverts during the field assessment, although it might flow through the culvert at higher flow. (Photo 6).

Photo 6: Double culverts at Leaning Tree Road stream crossing

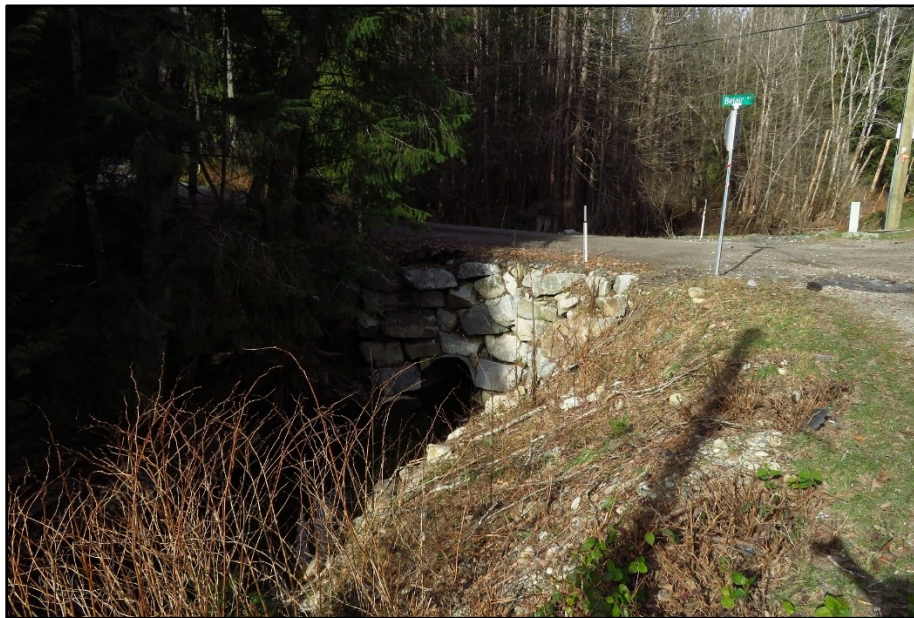
At Belair Road, a single 1200 mm culvert was about half full of water during our site visit (Photo 7). A metal grate is placed across the inlet of this culvert, presumably to prevent woody debris from blocking it.

Photo 7: Single culvert at Belair Road

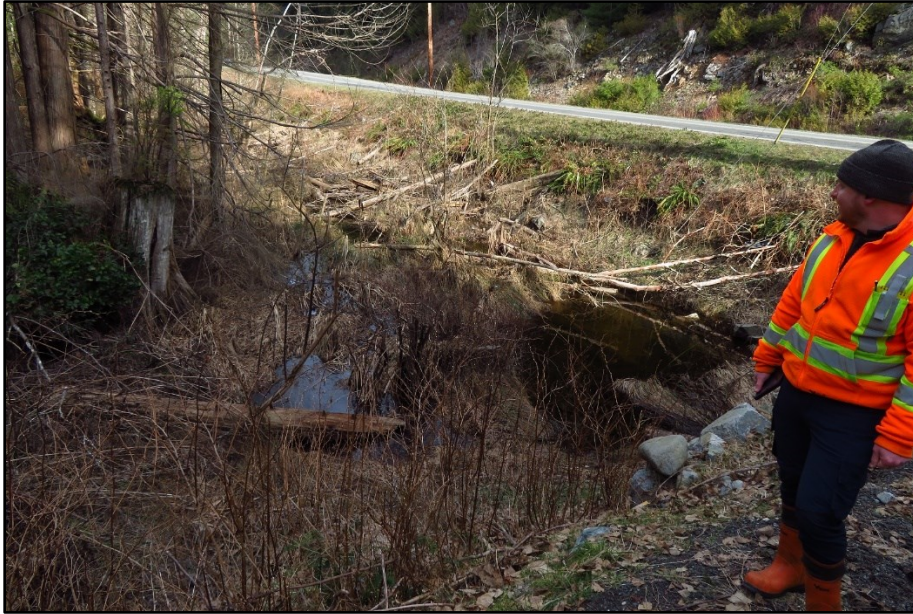
At both Leaning Tree Road and Belair Road, strand lines of sediment and wood showed that at previous high-water levels, likely associated with the November flooding, water had backed up upstream of both roads causing ponding (Photo 8). At both locations, ponding upstream of the

roads had resulted in up to 1 m depth of water outside the stream channel banks for up to 100 m upstream of each crossing. Neither crossing appeared to have been overtopped by the flooding, but some of the coarse rock fill at Belair Road appeared to be newly placed, so this crossing may have been repaired after the November flood and before our site visit.

Photo 8: Strandline shows extent of ponding during flood upstream of Belair Road

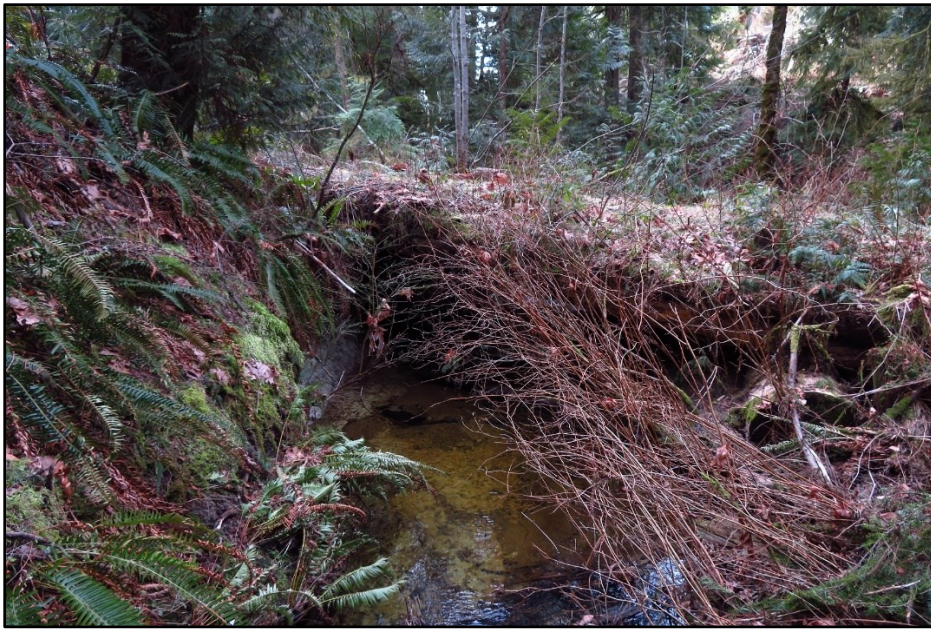
Between the two crossings, and upstream and downstream of them, Kenyon Creek flows in a forested valley bottom about 50 m west of Highway 101. Unvegetated stream banks at bends of the channel expose silty till, and up to cobble sized sediment moves in the channel. We found one old crossing where an abandoned private road crossed Kenyon Creek on a log stringer bridge, about 350 m downstream of Leaning Tree Road (Photo 9). The log stringers on this bridge are decaying and turning into nurse logs, and it is likely that this whole structure will collapse into the stream within the next few decades. On these stream channel reaches, we saw recent bank erosion at bends and sediment deposition on point bars that was likely caused by high flows during the November storm, but no evidence of extensive overbank flow or overbank sediment deposition outside the active stream channel.

Photo 9: Collapsing log stringer private land bridge downstream of Leaning Tree Road

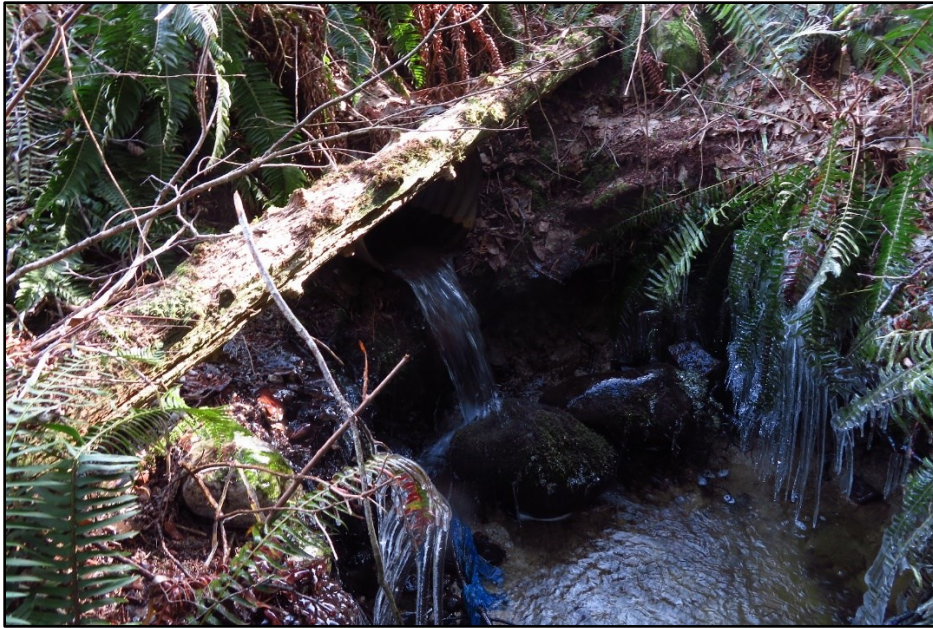
Along Highway 101 in this area, culverts are very widely spaced and small. Between Leaning Tree Road and Tapp Road, which is about 660 m south, we found only one culvert providing drainage under the highway. The culvert is a 500 mm diameter corrugated metal pipe culvert. The sediment under the outlet of this culvert was eroded (Photo 10), and the area near the inlet of the culvert, on the east side of the highway, had tussocks of living and dead vegetation that suggested it floods at high water, probably when the culvert backs up.

Photo 10: Erosion at culvert outlet between Leaning Tree Road and Tapp Road

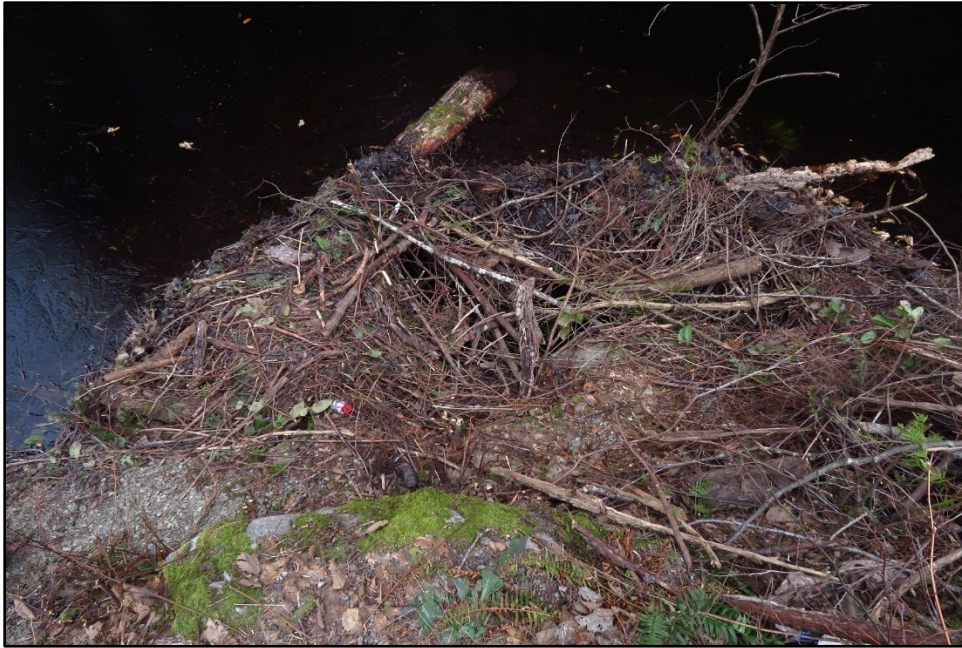
A 1000 mm corrugated metal pipe culvert passes under Highway 101 from the easternmost end of Trout Lake. The inlet and outlet of this culvert were both completely underwater at the time of our assessment. A beaver had blocked the Trout Lake (western) side of the culvert with woody debris and mud (Photo 11), while the eastern side was not blocked (Photo 12). The valley bottom to the east of the highway was flooded, creating a long, narrow pond that extended almost as far east as the junction where the Carlson Forest Service Road joins the highway (Photo 13).

Photo 11: Beaver debris blocking culvert inlet at Trout Lake

The culvert under Highway 101 at Trout Lake is also a factor in the damaging Kenyon Creek flood. BC MOTI may wish to remove this culvert or to replace it with a more beaver-resistant design.

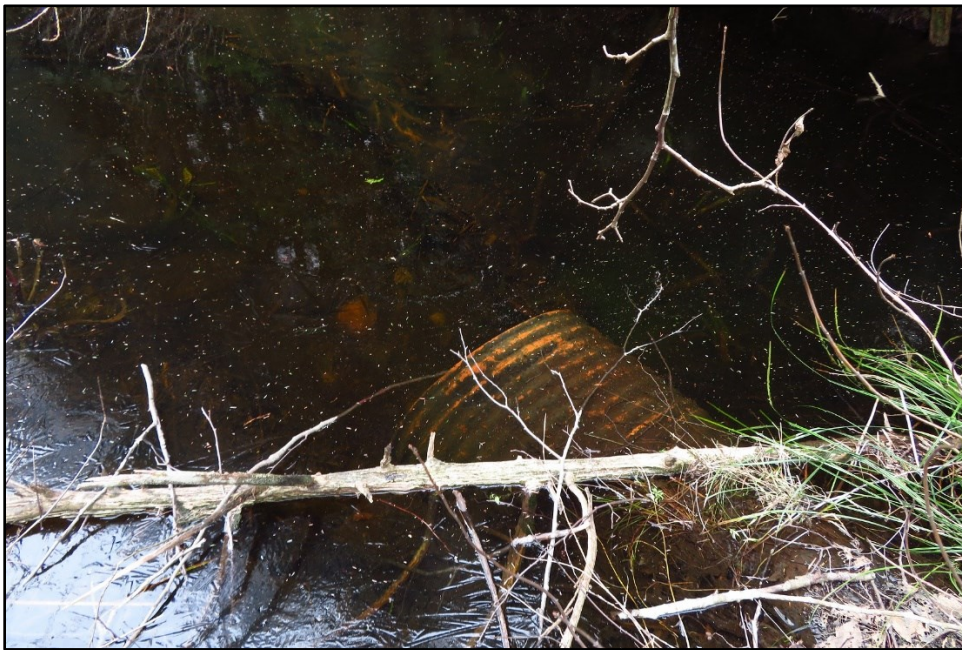
Photo 12: East side of culvert under Highway 101 from Trout Lake

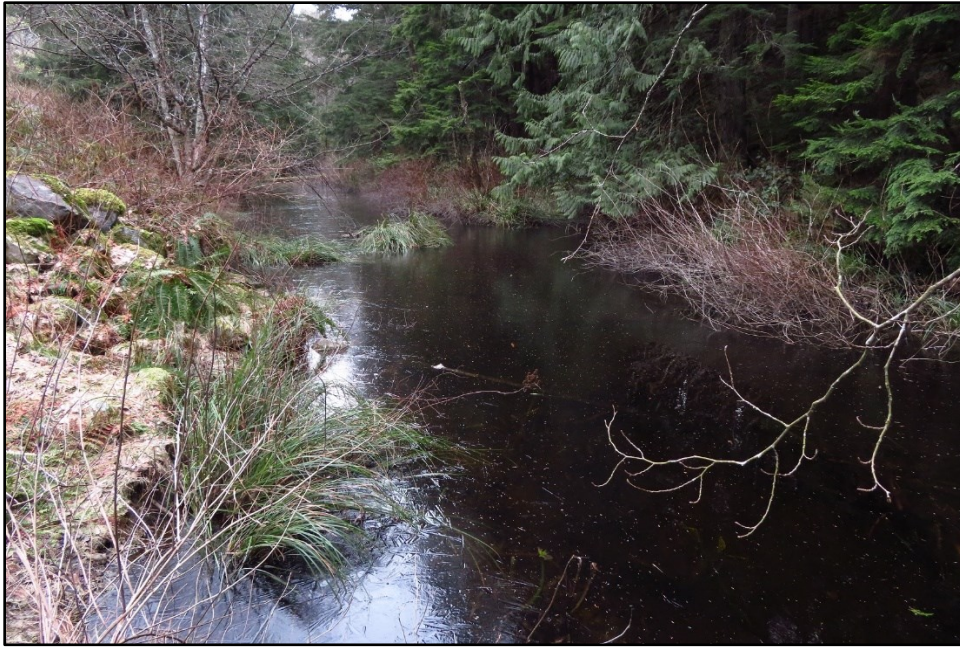
Photo 13: Ponding where water diverts across divide from Milne Creek to Kenyon Creek watershed east of Trout Lake

East of Trout Lake, Highway 101 crosses through a narrow, low-relief pass between the Kenyon Creek and Milne Creek catchments. The mapped location of the pass is about 170 m east of the east end of Trout Lake, or about halfway from the lake to the Carlson FSR. The original location and elevation of the drainage divide between these two catchments may have been modified by the construction of the highway; however, because of the low elevation of the pass and the placement of the culvert, it is clearly possible for water to flow out of Trout Lake at high water levels through the culvert and spill across the drainage divide, thereby flowing from the Milne Creek watershed into the Kenyon Creek watershed. This would reduce peak discharge in Milne Creek slightly and augment Kenyon Creek flows by the same amount, with the maximum contribution from Milne to Kenyon limited by the hydraulic head (water level above the top of the culvert inlet on the Trout Lake side) and the culvert's diameter.

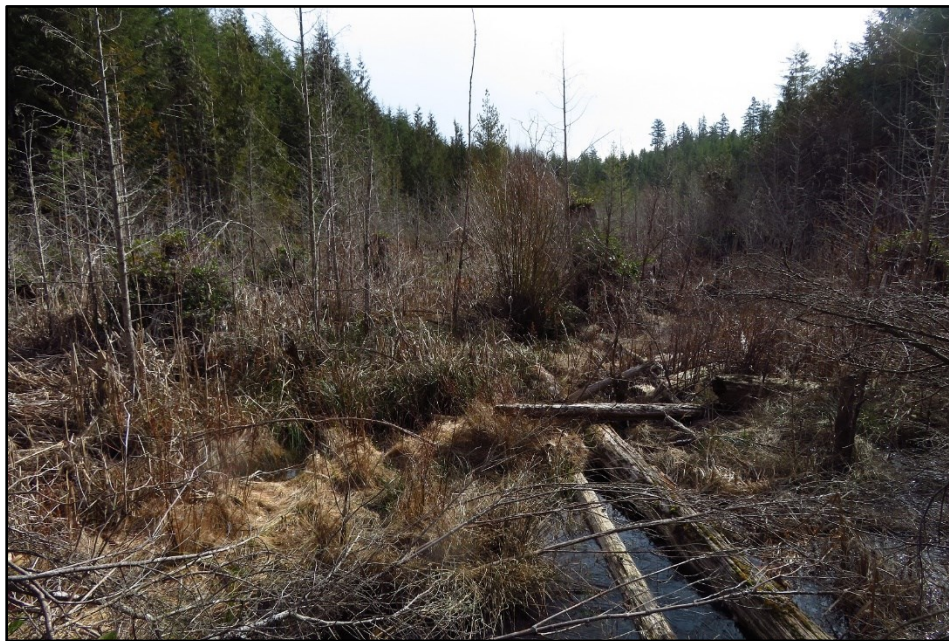
A small, triangularly shaped wetland is located upslope of Highway 101 and downslope of the Carlson FSR and BC Hydro transmission line right-of-way. This wetland has old stumps and snags in it and may have been created by past beaver activity (Photo 14). A stream flows from the western end of this wetland, down a short steep bedrock-controlled slope, onto level ground near the highway, then under the highway through a 600 mm CMP culvert, and into the wetlands in the headwaters of Kenyon Creek.

Photo 14: Wetland upslope of Highway 101 and downslope of Carlson FSR

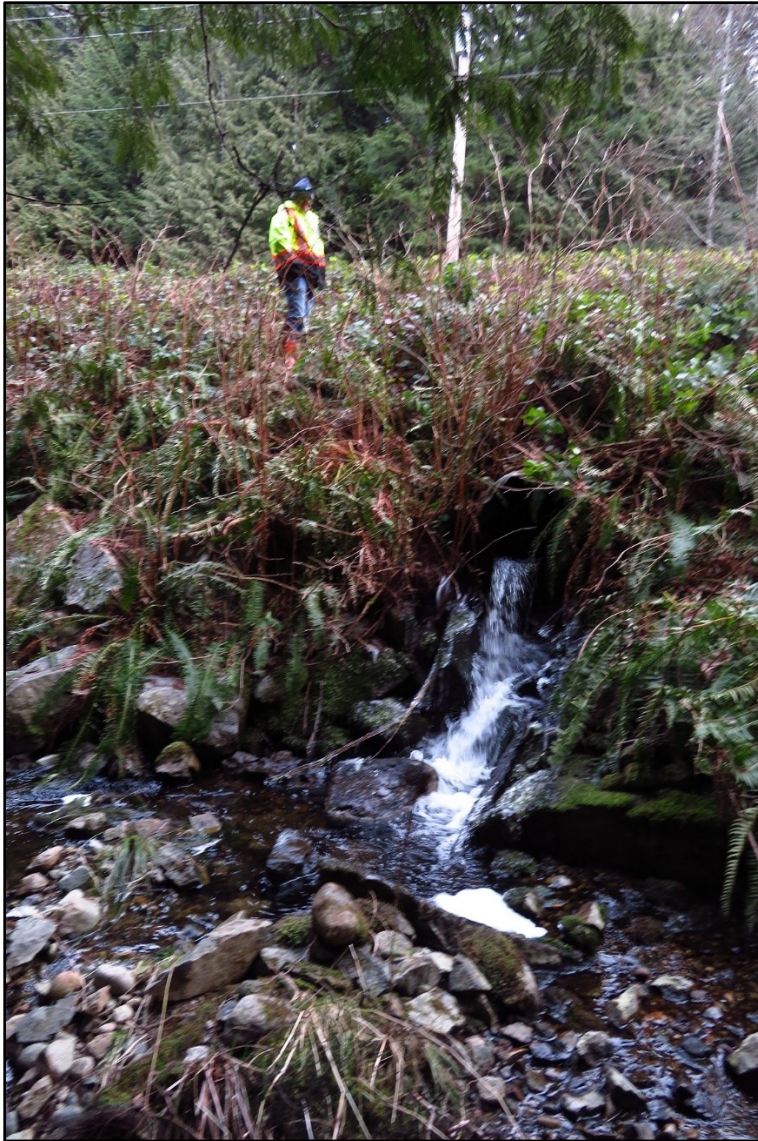
The stream reach that flows down the steep slope below the outlet of the wetland was scoured to bedrock and had avulsed, creating two parallel channels. These channels coalesced at the bottom of the steep slope and sediment had deposited there, about 50 m from the highway culvert. There was no sedimentation at the inlet of the culvert. The outlet of the culvert deposits onto coarse rock that appears to be old highway fill before flowing into the wetlands of upper Kenyon Creek and had slightly eroded that fill (Photo 15).

Photo 15: Outflow of highway culvert coming from Carlson FSR

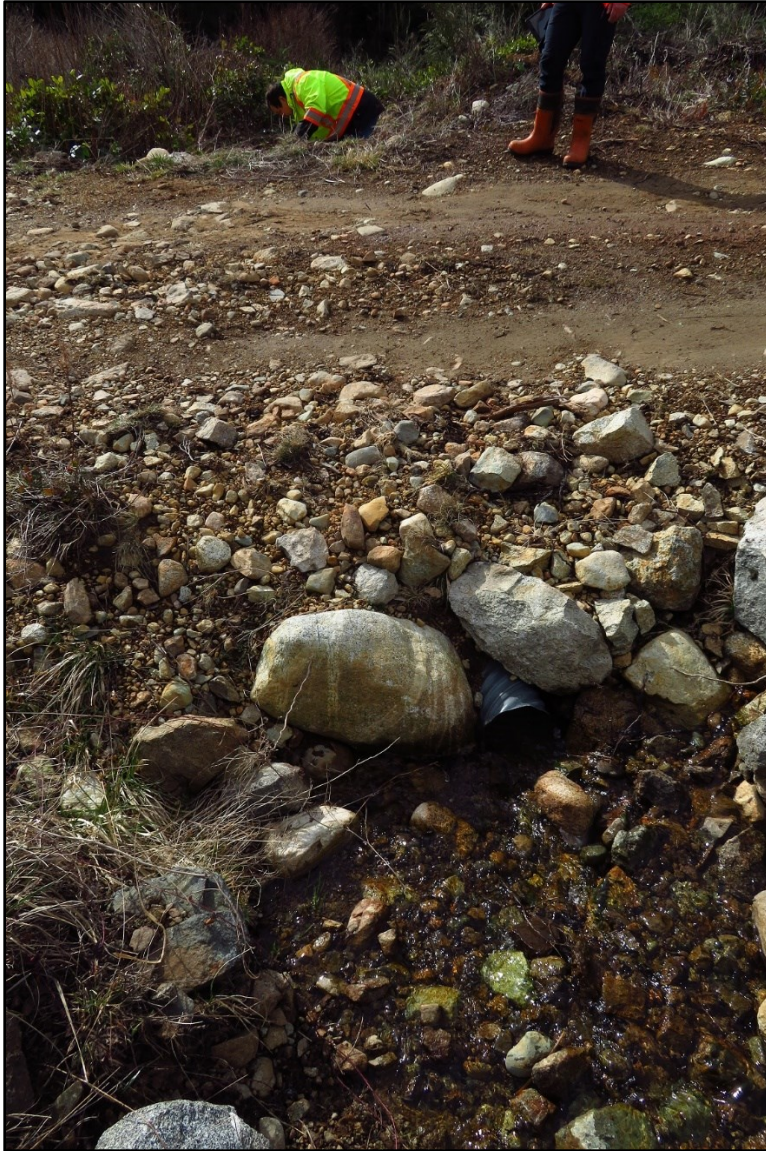
Two smaller, probably ephemeral streams flow from the forest upslope of the BC Hydro right-of-way and across the right-of-way, then join and flow into the wetland. These streams are conveyed across the hydro right-of-way access road in very small (300 mm diameter) CMP culverts but flow under the FSR through larger, 600 mm diameter CMP culverts. At the time of my assessment, both stream crossings along the Hydro access road were eroded by flow that had exceeded the small culverts' capacity and run across the access road (Photo 16). There was no corresponding erosion

of the FSR, indicating that the flow in these streams had not exceeded the capacity of the larger culverts.

Photo 16: Tiny culvert under BC Hydro access road

In addition to BC MOTI culverts, several of the culverts in place at stream crossings along the BC Hydro powerline access road are significantly undersized and had their capacity exceeded during the November storm. SCCF should provide this information to BC Hydro so that they can replace and upgrade their undersized culverts.
