MILNE COMMUNITY WATERSHED ASSESSMENT

Halfmoon Bay, BC

Project Number: 19-183

March 1, 2021

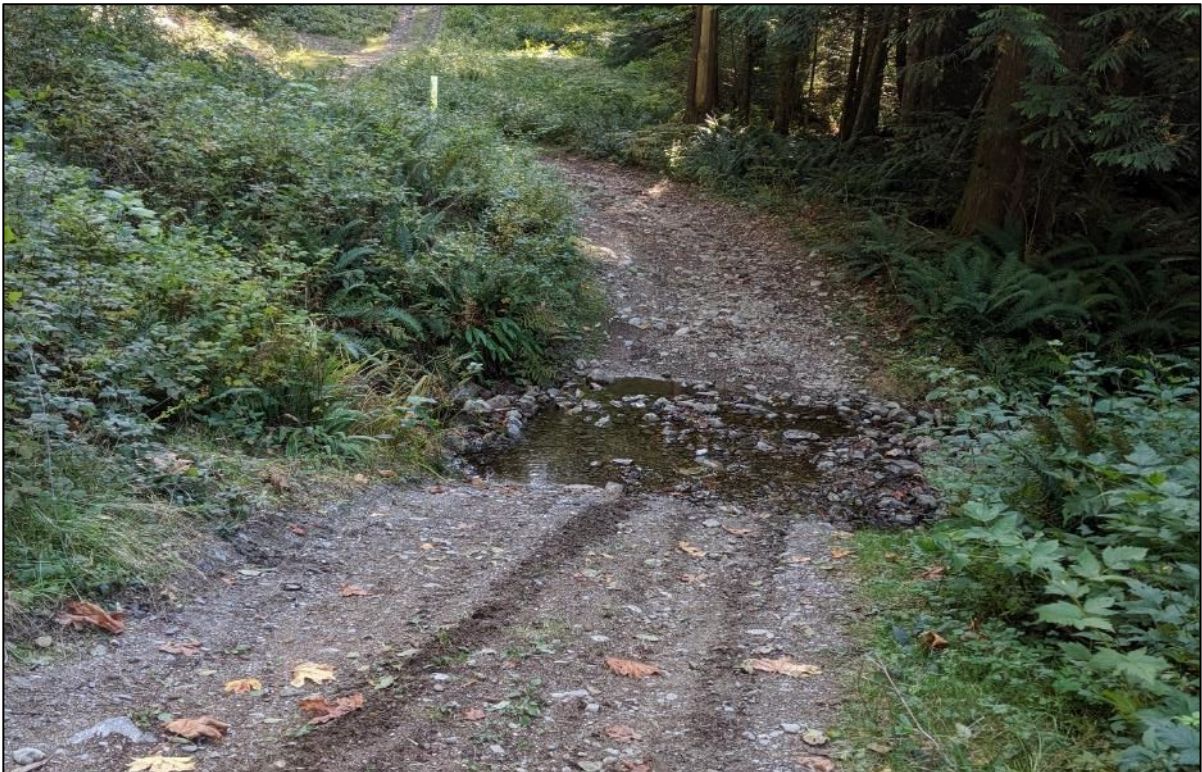
Several roads provide access to the power transmission line and natural gas pipeline rights-of-way. These roads cross the hummocky terrain north of Trout Lake. Some of these roads have pooling water and localized erosion. Most of the sediment from the eroded segments deposits in depressions that are not connected to the stream network. These roads are used by mountain bikers and motorized recreational vehicles (motorbikes, ATVs, or UTVs). Motorized recreational vehicles cross a ford on a natural gas pipeline road, where the access road is parallel to the FSR, leading to increased erosion at the crossing (Photo 1). I did not observe structures meant to control erosion or sedimentation on the access road.

Photo 1: Ford crossing the natural gas pipeline road, without erosion sediment and control structures and no means to prevent recreational use.

The moderate to high risk associated with roads can be managed and reduced by identifying unneeded roads in the watershed and deactivating them, but much of the risk results from the permanent access corridors of the transmission line, gas pipeline, and highway. This risk will not be changed by the forestry activity if planned roads are constructed as temporary roads and deactivated soon after use. The incremental risk resulting from forestry roads in the watershed is low.

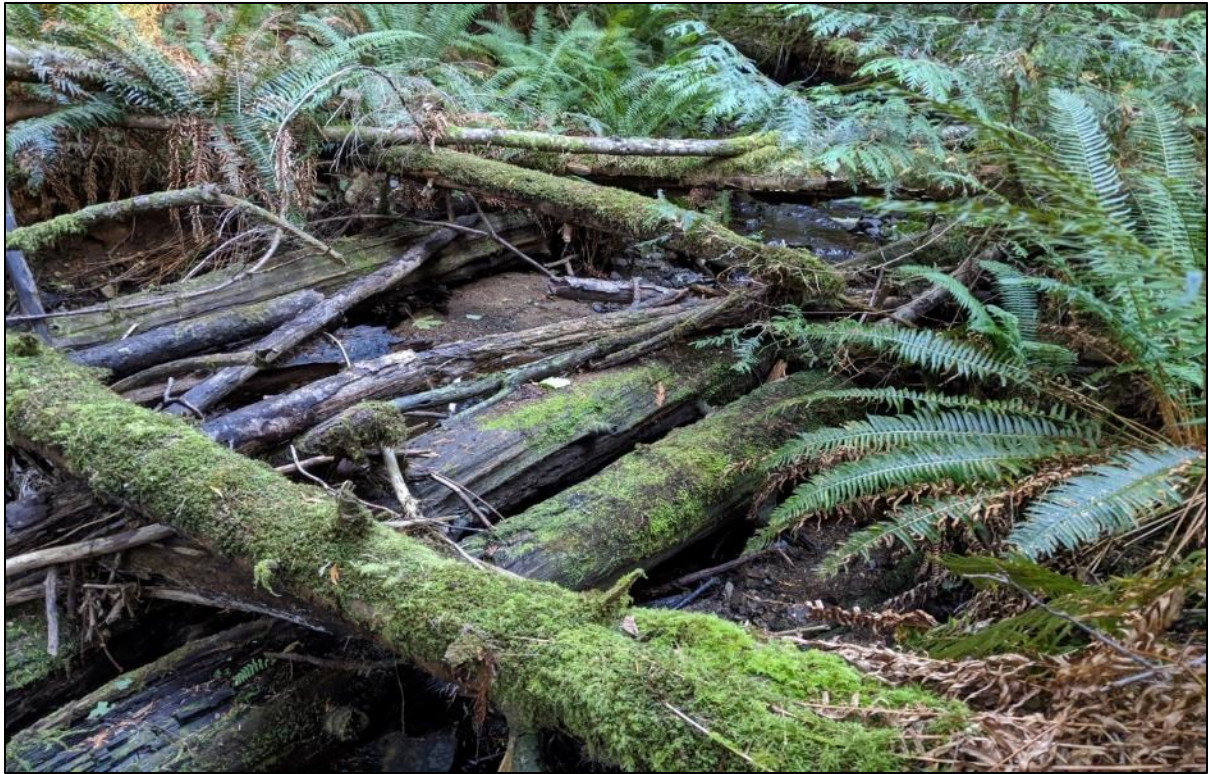
Milne Creek, from Highway 1 to the lowest point within the watershed has a step pool morphology with a primarily bedrock channel. Fine sediments (gravels and sands) deposit in pools. Abundant coarse woody debris is present near and in the channel, with many logs shading the channel (Photo 2). There were several water intake pipes along the reach, but they had been damaged by a high flow event. It is likely that they are no longer in use because they had not been repaired.

Photo 2: Milne Creek. Note the coarse woody debris jam with wedge of fine sediment in middle of image. The stream flows under the logs, from top of photo to lower left.
